**MILAN ARMY AMMUNITION PLANT**

**Remedial Investigation Report**  
VOLUME I

**December 1991**

REMEDIAL INVESTIGATION REPORT  
FOR -- TASK ORDER NO. 4  
MILAN ARMY AMMUNITION PLANT  
REMEDIAL INVESTIGATION

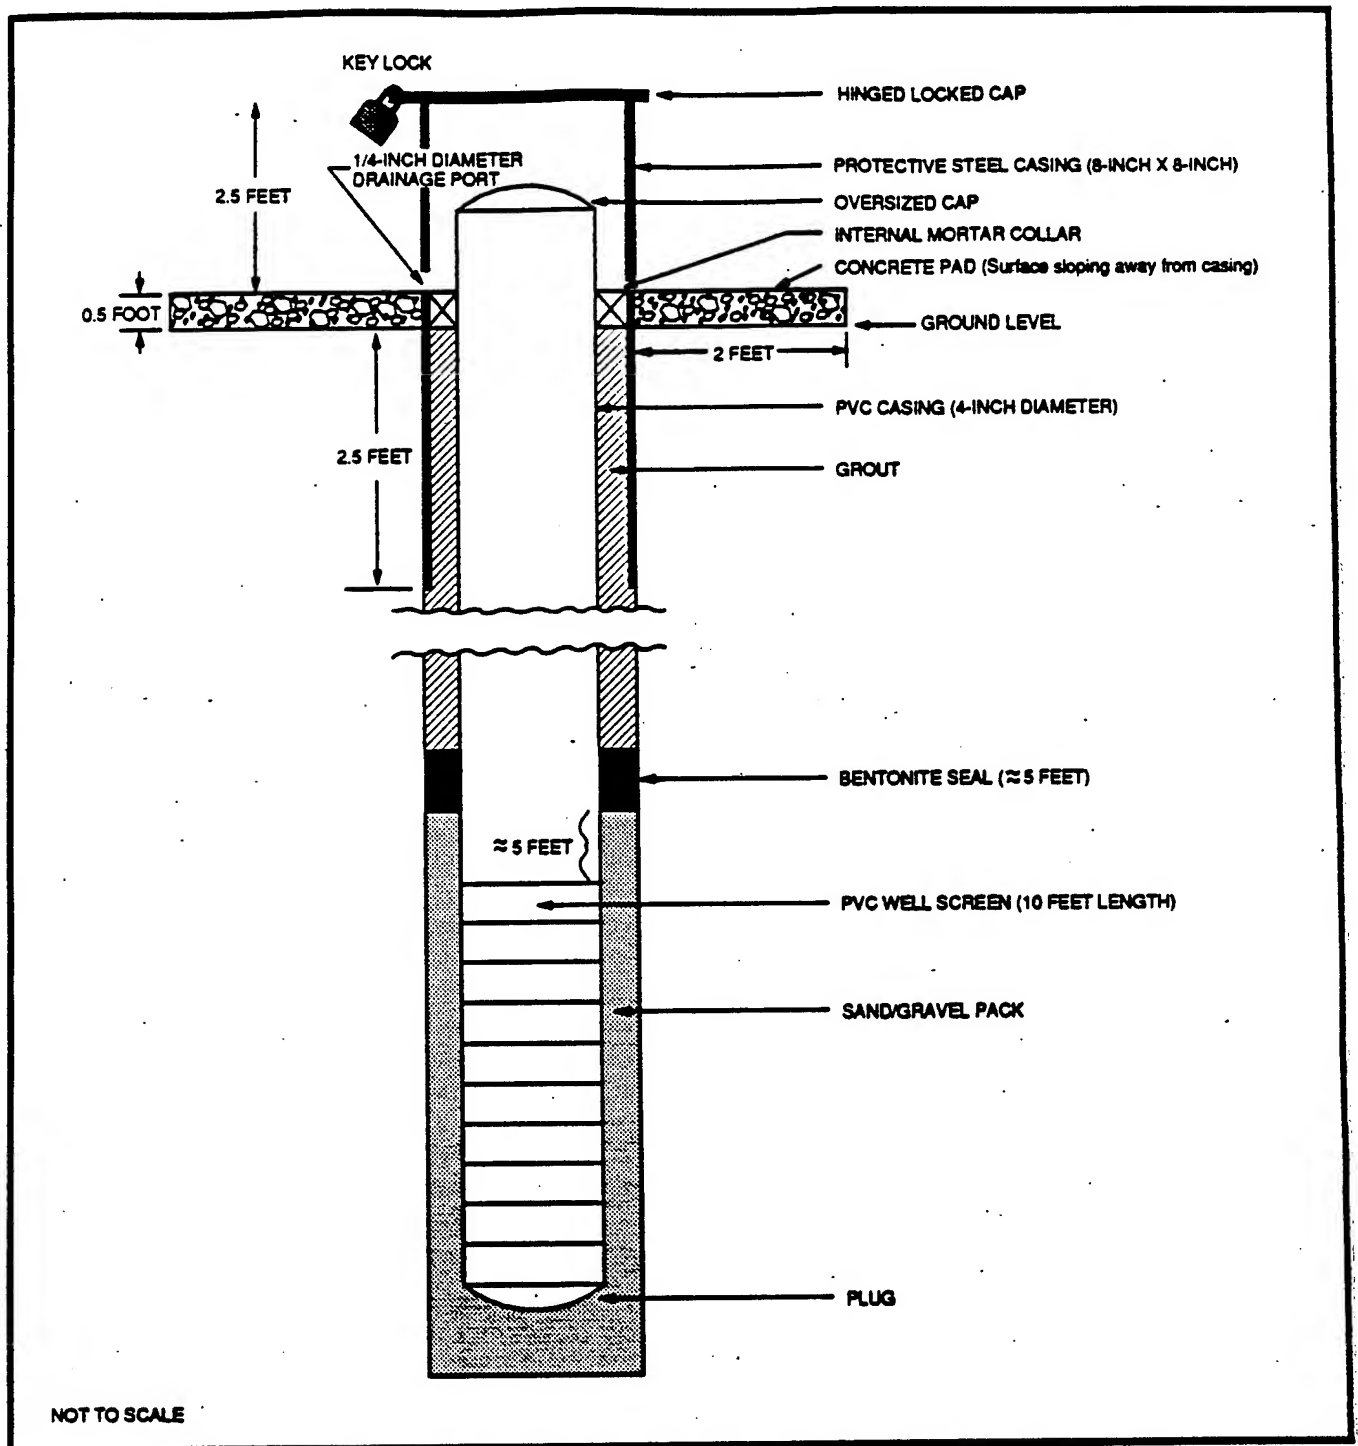
**Figure 4-15**  
**Groundwater Monitor Well Construction**

The grout used in well construction was composed by weight of 20 parts Type II Portland cement to one part Baroid Quik-gel bentonite, with a maximum of 8 gallons of approved water per 94-pound bag

of cement. Bentonite was added after mixing of the cement and water. Specifications and a sample of bentonite were submitted to USATHAMA for approval prior to use.

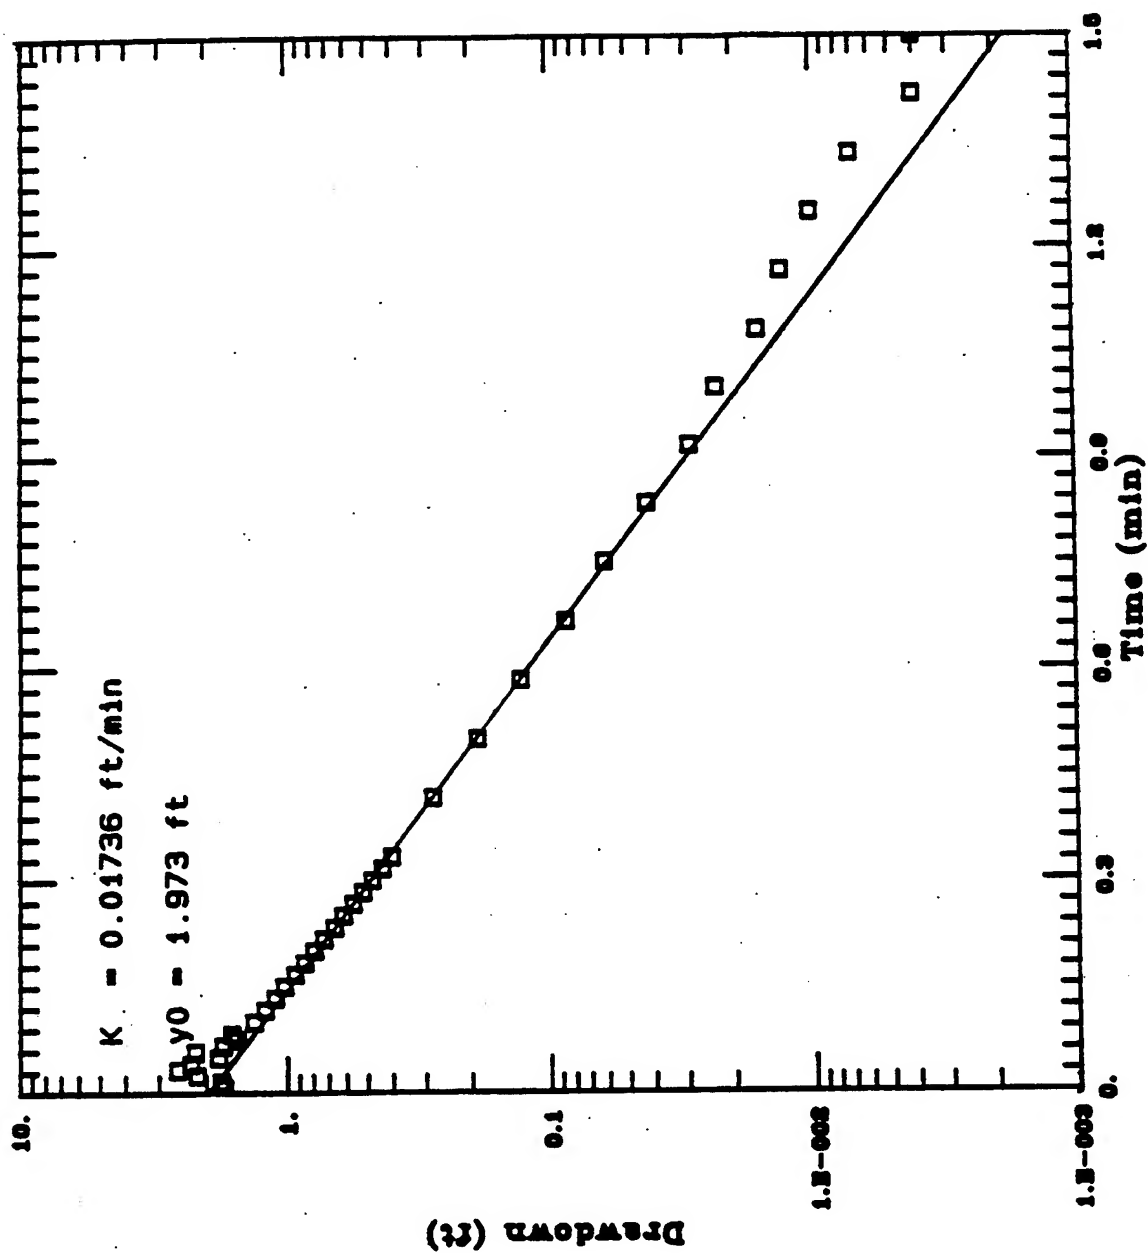
Figure 5-3  
 Falling Head Slug Test Data from Well MI057

In addition, very little drawdown was recorded in observation wells near the pumping wells. This indicates that the cone of influence resulting from pumping diminished significantly over a relatively short distance, and that the total drawdown observed in the aquifer was concentrated around the pumping well. Therefore, the hydraulic conditions present around the pumping wells during recovery tests are similar to conditions present during rising head slug tests. Although the application of a slug test solution to recovery data is not a conventional approach, it provides a valid estimation of  $K$  surrounding the pumping well, and it is a useful estimate for comparison with other results. It should be noted, however, that only the rate of recovery in the pumping well was analyzed in this fashion, as the drawdown was symmetric around the well casing, which is similar to slug test conditions. Drawdown surrounding an observation well is asymmetric, and flow conditions to the observation well during recovery are different than those surrounding a pumping well.

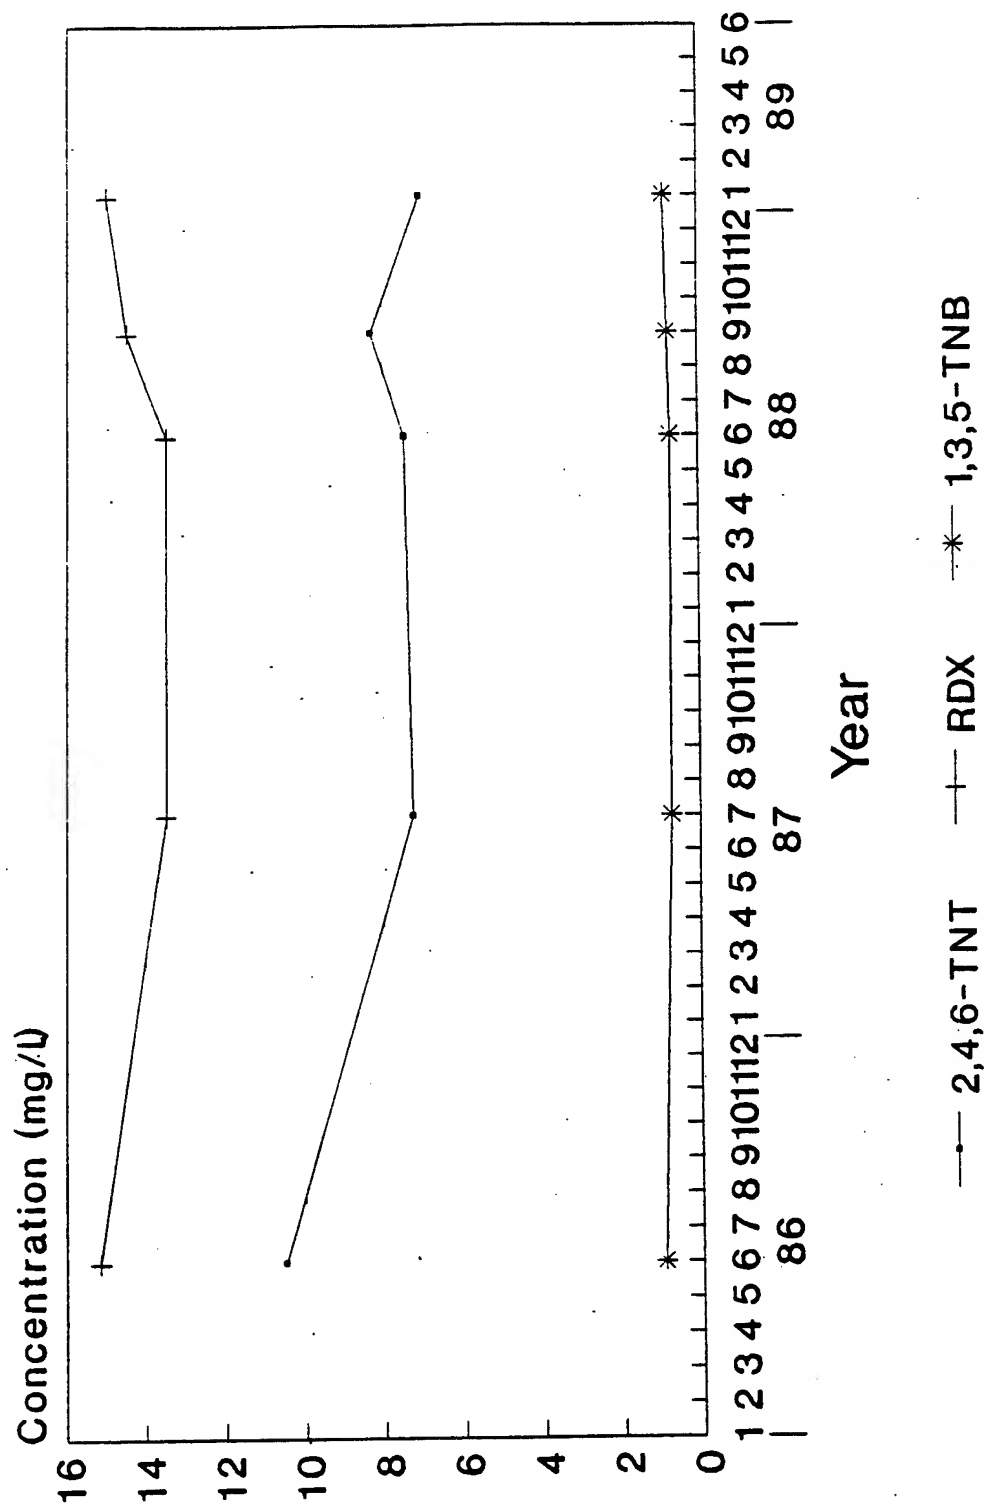
FIGURE 7-1  
Concentrations of TNT, RDX, and TNB Detected in MI001 Between 1986-89

1. The cap is not leaking and contaminants are no longer being contributed to groundwater by the existing soil contamination. However, the magnitude of the groundwater velocity is so small that contaminated groundwater which was on the south (upgradient) side of the ponds at the time of capping (1983) has not yet moved past the monitoring wells on the north (downgradient) side of the cap. After this "slug" of contaminated water passes the wells, the detected levels should decrease rapidly in time.
2. The cap is not leaking but past use of the ponds resulted in a column of nearly-saturated soil under the cap which extends from the bottom of the former ponds to the water table. The water in this column is slowly draining over time and loading contaminants into groundwater.

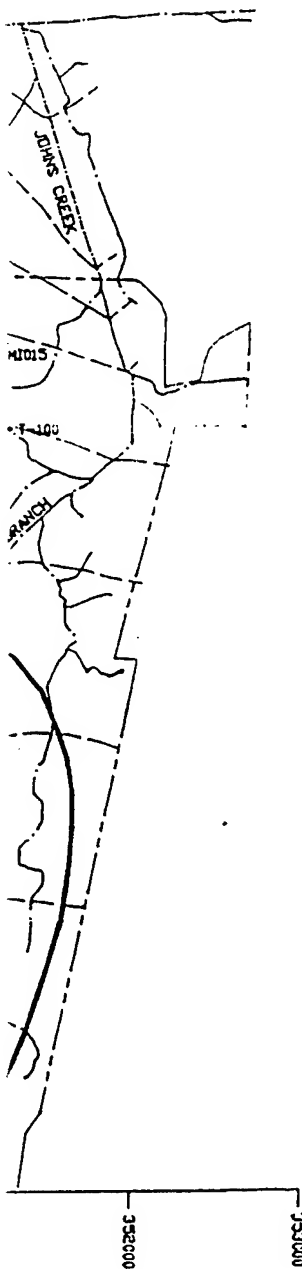
<b>ICF KAISER ENGINEERS</b>		8300 LEE HIGHWAY FAIRFAX, VIRGINIA 22031-1207
TITLE MAAP REMEDIAL INVESTIGATION		
FIGURE 7-16 TNT CONCENTRATIONS ASSOCIATED WITH THE OBG/ADA AND OTHER SOURCES		
SIZE <b>B</b>	PROJECT CODE <b>30874</b>	DWG NO. 05109102
SCALE: NONE DRAWN BY: D. ALLEN		CHECKED BY: N. OKUSU

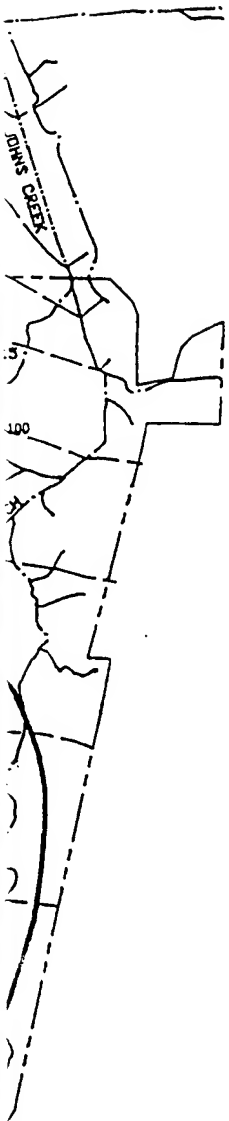
<b>ICF KAISER ENGINEERS</b>		8300 LEE HIGHWAY FAIRFAX, VIRGINIA 22031-1207
TITLE MAAP REMEDIAL INVESTIGATION		
FIGURE 7-19 2,4-DNT CONCENTRATIONS ASSOCIATED WITH THE OBG/ADA AND OTHER SOURCES		
SIZE <b>B</b>	PROJECT CODE <b>30874</b>	DWG NO. <b>05109105</b>
SCALE: NONE DRAWN BY: D. ALLEN		CHECKED BY: N. OKUSU

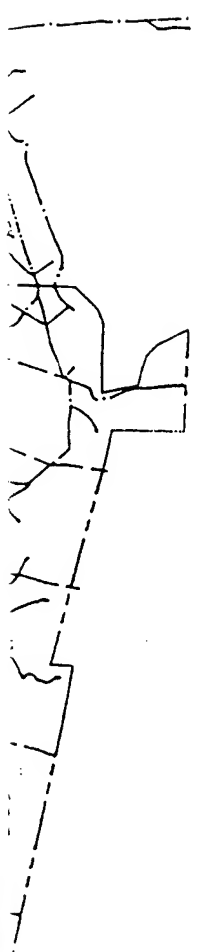
<b>ICF KAISER ENGINEERS</b>		8300 LEE HIGHWAY FAIRFAX, VIRGINIA 22031-1207
TITLE MAAP REMEDIAL INVESTIGATION		
FIGURE 7-22 CHROMIUM CONCENTRATIONS ASSOCIATED WITH THE OBG/ADA AND OTHER SOURCES		
SIZE <b>B</b>	PROJECT CODE <b>30874</b>	DWG NO. 05109110
SCALE: NONE		DRAWN BY: D. ALLEN
		CHECKED BY: N. OKUSU
